Home Tech NJ Inspections Services LLC

INSPECTION REPORT

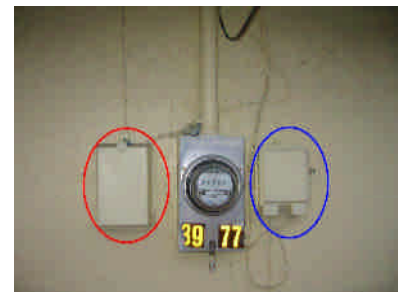
Type & Condition: Overhead.

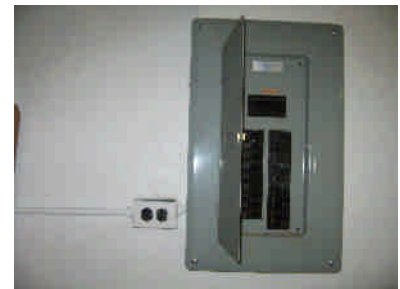
Main Panel: Garage. Appears serviceable.

Circuit and wire sizing correct so far as visible, Grounding system is present, Multiple wires are connected to a single lug on a circuit breaker where only one wire should be connected- noted at two 20 amp single pole breakers on the right. Missing strain relief at panel, Have a licensed electrician make further evaluation and corrections as needed.

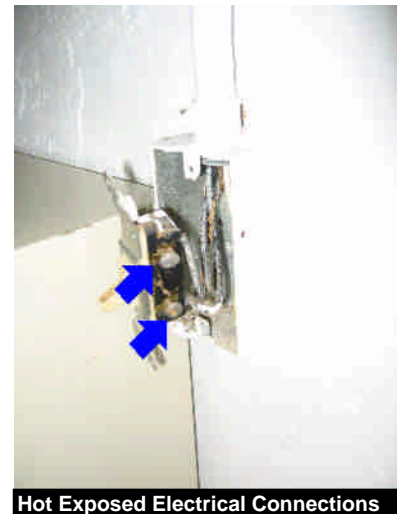
General: A representative sampling of switches was tested. As a whole, switches throughout the house are in serviceable condition, however, one in the garage is exposed and dangerous. Repairs needed. Lights are not operational in some areas, possibly due to bad bulbs.

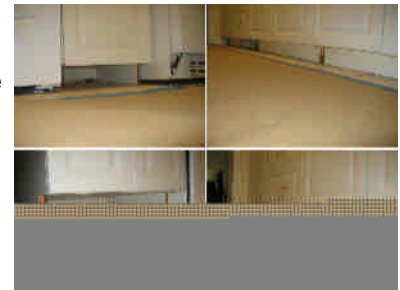
Counters are Formica (plastic laminate), with minor wear or cracking, Caulking is needed in the vicinity of the sink. Base cabinet kick plate is missing in some areas. See photos.
